**BULLETIN OF THE
SERVICE CITIZENS OF DELAWARE**

**GENERAL REPORT ON
SCHOOL BUILDINGS AND GROUNDS
OF DELAWARE**

OCTOBER 15, 1919

GEORGE D. STRAYER

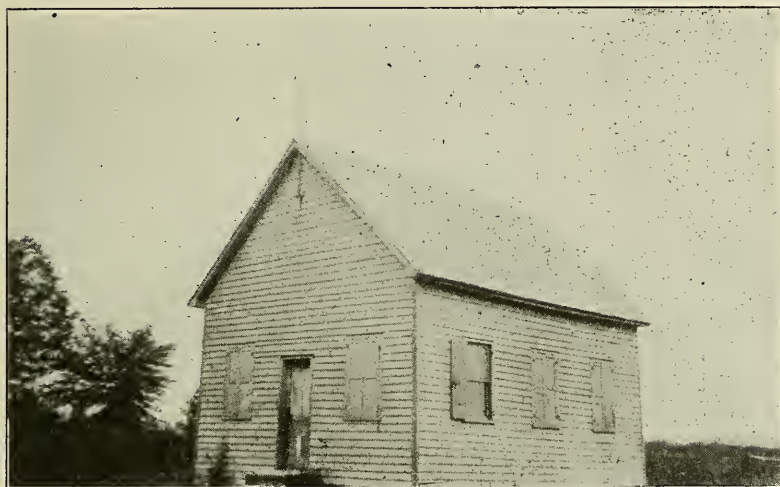
GLASGOW NO. 114

The Glasgow School is a four-walled, frame structure, without vestibule or protected entrance. It has a tin roof and is in general

bad state of repair. It is located on a small triangular plot of worthless land adjoining low, swampy ground. On no single item considered does the building justify its use for school purposes. The total score of 209 out of 1000 justifies the recommendation that this building be closed to school children.

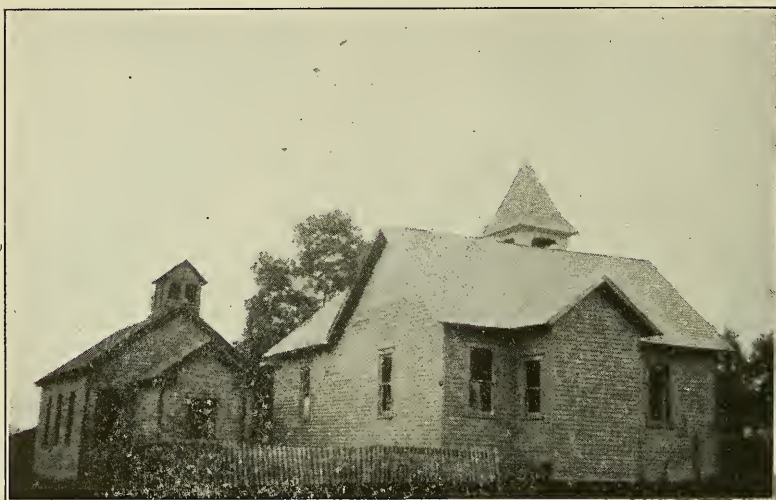
The school for colored children in St. Georges is a one-room, rectangular, vestibuled type of frame building, located on a small

site in the rear of the colored church. As clearly shown in the picture, there is no opportunity for play and little possibility of the development of an adequate recreational ground. The building is poorly equipped, poorly lighted and unfit for school purposes.

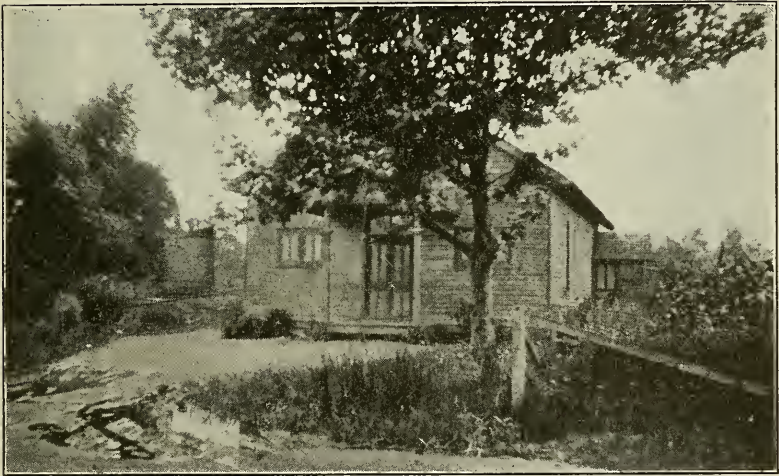
DELAWARE CITY DISTRICT NO. 118

NOTE--Marsh to the left with Canal boat back of it

The building itself, except for the Waterbury heater, is but little better than the environment in which it is placed. There can be little hope for the education or Americanization of children that are required to secure their education under conditions such as are found in this building.

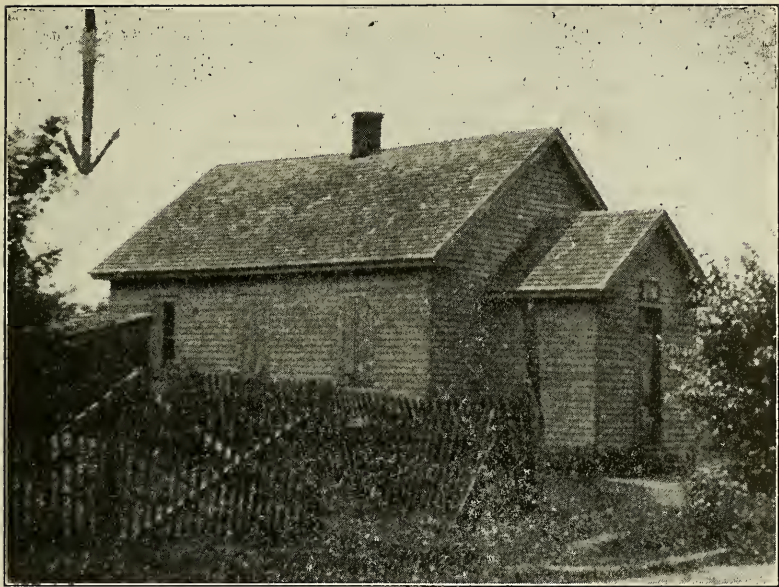
MT. PLEASANT SCHOOL

Shelter and to a degree protection from cold, inclement weather is all this building has to offer the children that are supposed to attend it. It is disqualified and condemned on every major item of the score card and reference to the detail scores will further emphasize the educational lacks. It is of special note that this building has but one toilet for the two sexes and that in the class

Note arrow to the left of school house pointing to pig sty.

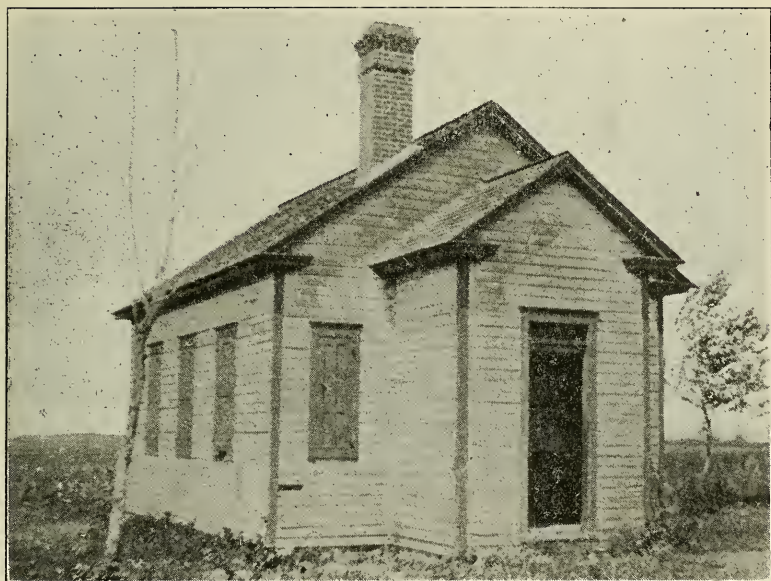
PORT PENN SCHOOL

Altho scoring above the medium for colored schools of the country, the Port Penn building is in every major respect far below acceptable standards. If the present location of the school should appear to be the most satisfactory, the size of the site should be extended by from four to ten acres and a properly planned building constructed. It seems fair to note that this colored school did have two toilets, altho they were in very unsatisfactory condi-

tion. The building is heated by a jacketed heater of good quality and in this respect is better than others of its class.

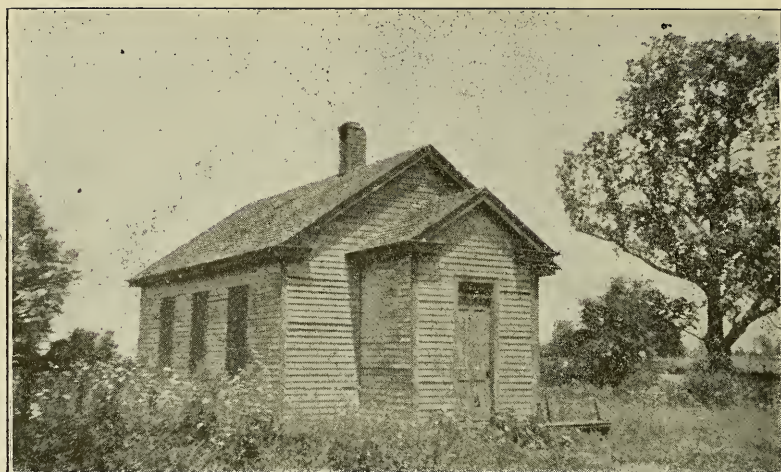
CONGOTOWN NO. 123
(Colored)

This building has nothing commendable about it except the improved highway which makes it fairly accessible. Its environment is not pleasing; the site is so small as to be of no consequence and the little that is not occupied by the building is overgrown with briars and bushes. The two sexes are provided with but one toilet, the condition of which is very bad. The adequacy of the class room is indicated by the very low score of 57 points out of 225. The building should be closed for school purposes and the site abandoned.

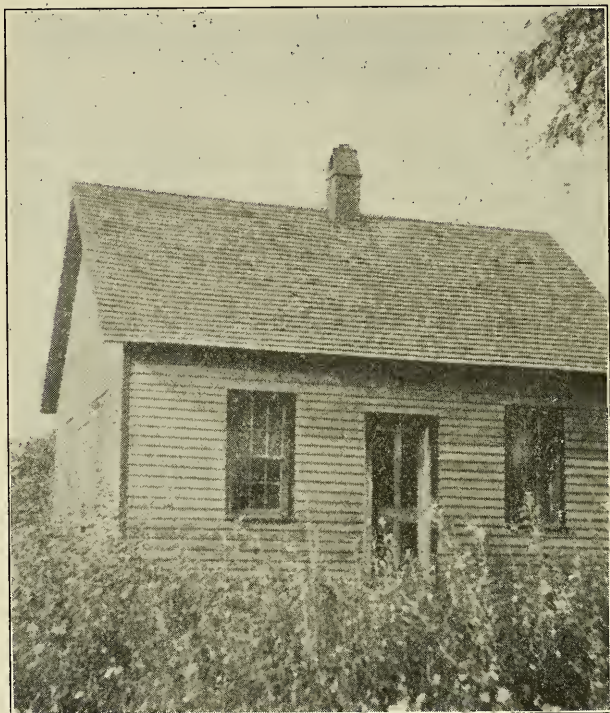
BLACKISTON'S NO. 137
(Colored)

This is a one-room frame building with unprotected entrance on the long axis of the building. It is in a dilapidated condition, and the entire surroundings are unsuited to the needs of the community. The grounds are overgrown with briars and bushes, and the entrance to the grounds is so low that at the time of the survey the building was almost inaccessible. The class room is lighted on three sides and is supplied with the very minimum of ancient and mutilated equipment.

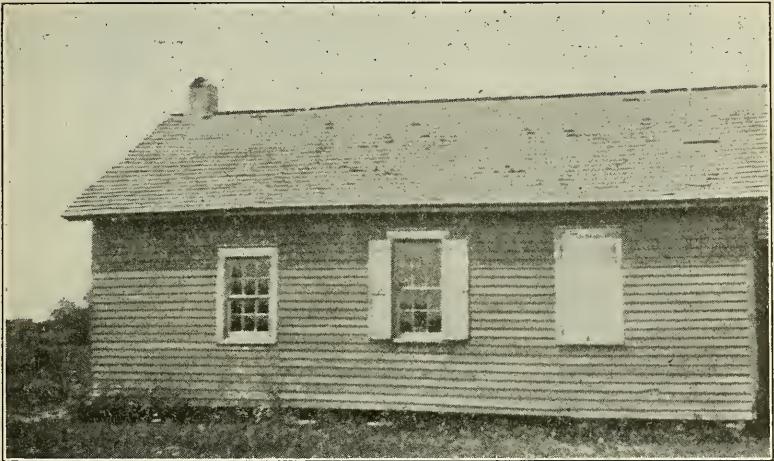
BLANCO NO. 138
(Colored)

This is a one-room frame building, 18x30, with vestibuled entrance. The site is too small for present needs and is so located as not to be convenient of extension. The building scores but 19 points out of 250 on service systems and offers a minimum of class room facilities. The score by individual items and totals is sufficient justification for the recommendation that the building be abandoned.

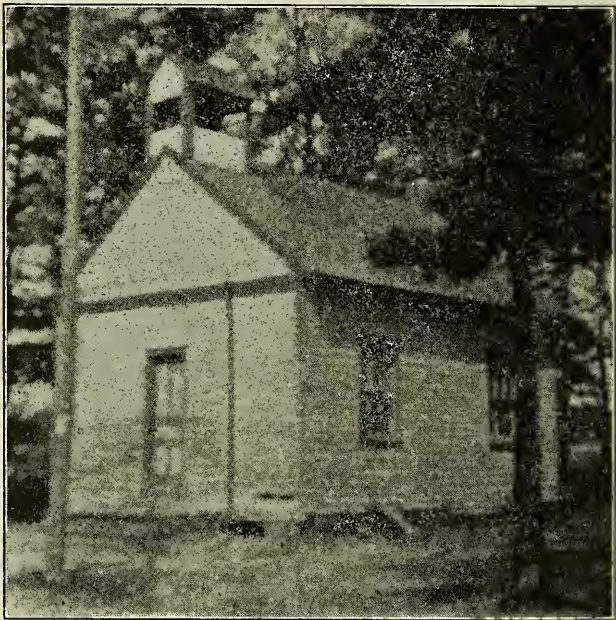
SANDFIELD NO. 141
(Colored)

This is a very old frame building of the box type with open foundation. The building is 16x20, and the size of the site is indeterminate because of the fact that it is located in the woods, only the underbrush having been cut away to allow for the placement of the building. The elevation of the land is such that should this site be made permanent a large clearing would make a fairly desirable school site. The score of 30 out of 200 points on the building proper is indicative of the fact that little loss would be entailed in the complete abandonment of the building.

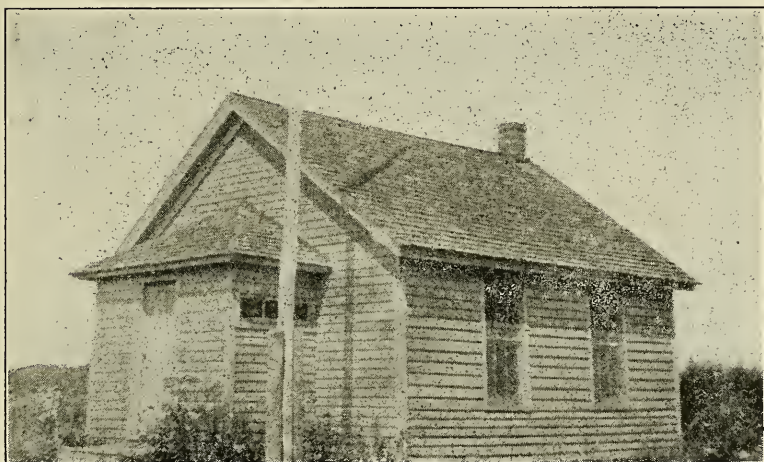
MARYDEL NO. 153

The Marydel colored school is a one-room frame building, 18x20, located on a small indeterminate school site, joining a church yard. The building is very old and in a dilapidated condition. It is heated by a box wood stove and offers absolutely no facilities in the way of water supply or toilet systems. The class room and class room equipment are of the meagerest type and utterly unfit for use. The building should be closed and the children transported to a new building constructed upon a suitable site.

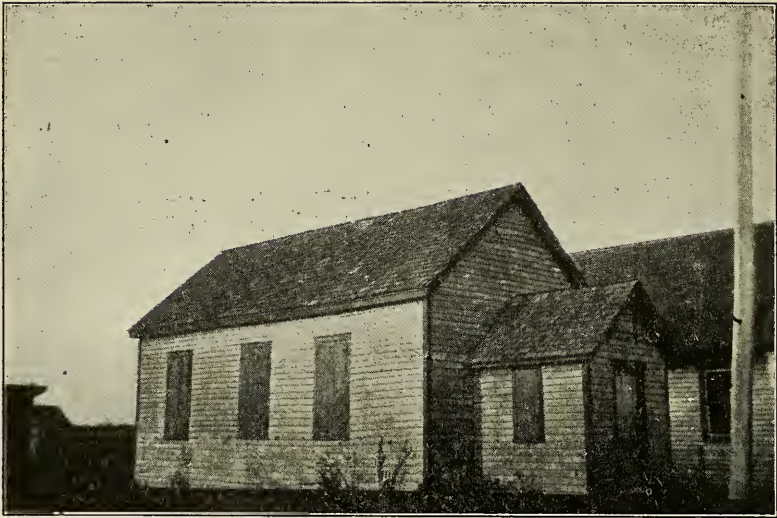
ELLENDALE SCHOOL

This is a very old, one-room, vestibuled frame building, 14x28, on a brick foundation in very bad condition. It is located in a churchyard and offers little opportunity for play or recreational facilities. Service systems are either entirely missing or of the most meager type possible. The class room is small, dirty and in general uninhabitable. The glass area is low and distributed on

three sides of the room, one of which the children are compelled to face. The building should not be used for school purposes and cannot be made by alteration into an acceptable school building.

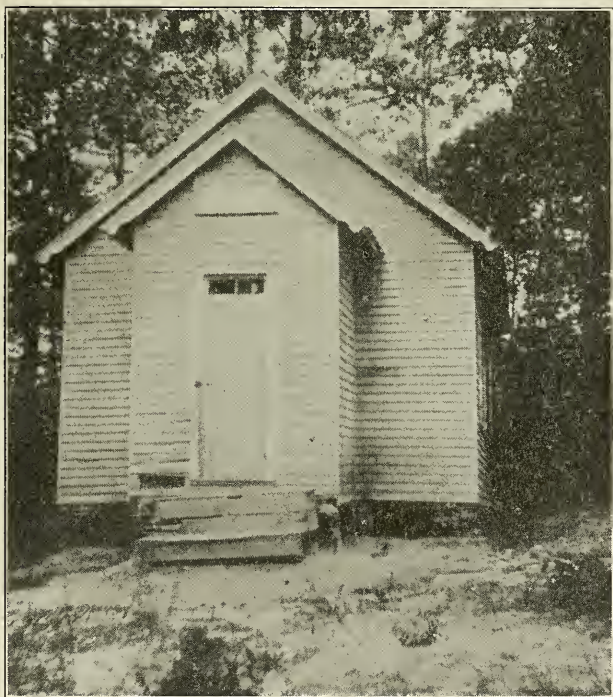
MILLSBORO SCHOOL

This is probably as poor a school building as can be found in

Delaware. Its score of 111 points indicates that practically nothing exists about this school which is worthy of mention. Torn, ragged, out-of-date maps are samples of the type of equipment. A floor full of holes and patched in places by nailing on a second layer of broken board indicates in what condition the interior of this structure was found. Weeds were actually growing through the floor of the schoolhouse. The majority of the blackboards were painted wooden boards with a large part of the paint worn off. The building is located in what was once a clearing on a forest road, in the midst of a dense forest. The clearing had become overgrown to such an extent that it was impossible to see the outhouses, if there were any, from the road. The State of Delaware should not permit this building to be used as a schoolhouse a moment longer than it will be necessary to build a high-grade, modern plant for these children.

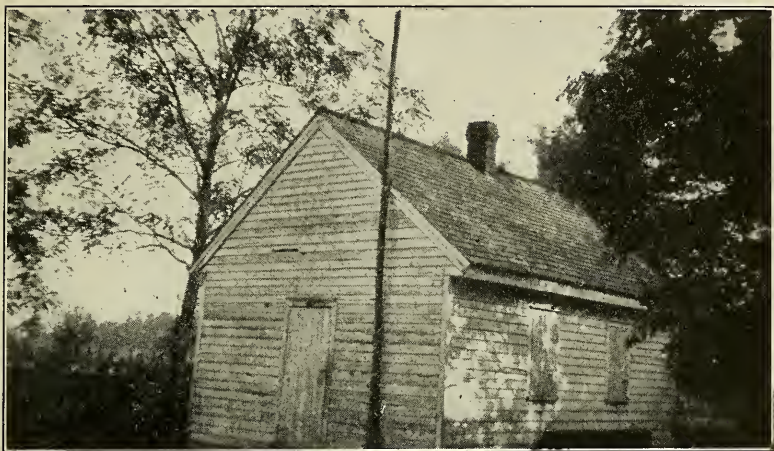
WHARTON SCHOOL

Wharton's Branch Colored School is housed in a very old one-room, one-story frame building, which is located on a small, irreg-

ular site, approximately 100x150 feet, surrounded on three sides by oak woods and underbrush. The building is 14x20, of the non-vestibuled type, lighted from three sides with the seatings so arranged as to compel the children to face an open window. The entire structure is in the last stages of decay. From the exterior one would never suspect that school children would be housed in such quarters. The

interior is no more satisfactory than the exterior. The ceiling is seven and one-half feet high and the floor, which is badly worn, is sagging down at either end to such an extent that it is out of level by as much as twelve inches. This building has absolutely nothing to recommend its continued use for school purposes, and everything to warrant the recommendation that it be closed, and that in its place a modern school structure be provided.

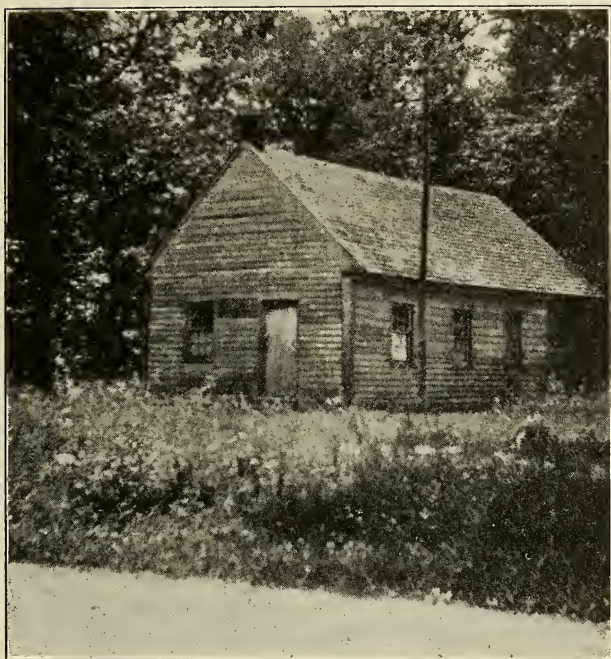
TRINITY SCHOOL

This building is a one-room frame structure, without vestibule. It is approximately 18x32 feet in dimensions. The character of the foundation could not be ascertained without the removal of boards, which were buried in the ground. The roof is moss-grown, and the entire building is in the last stages of decay. It is located in a churchyard at the intersection of poorly graded, unimproved roads. The building is heated by a box stove. It has neither clock nor bell; no provision has been made for either drinking or washing facilities and no toilet accommodations whatever are provided. The glass area of the class room is less than one-half of what it should be, and what it has is distributed on opposite sides of the room. No window shades are supplied and no provision made for cloak rooms. The only commendable feature of the building is the new double desks which have been installed. These are in good condition, but double desks do not meet standard requirements. This building

should be abandoned absolutely and the children of the community provided with a new and modern schoolhouse.
